Navajo Abandoned Uranium Mine

Site Screen Report

Charles Huskon No. 3 AUM Site

January 2011

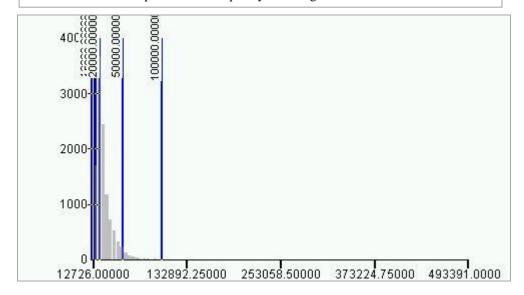
A total of 11,299 gamma radiation measurements were collected from the mine site, ranging from 12,726 cpm to 493,391 cpm. The measurements collected at the waste piles were found at maximum levels ranging from approximately 300,000 cpm to 500,000 cpm, and at the reclamation cap at average levels ranging from approximately 20,000 cpm to 40,000 cpm. The measurements are represented in Figures 1, 2, 3, and 4.

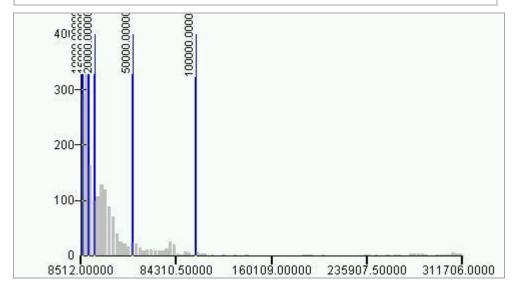
A total of 1,794 gamma radiation measurements were collected from the mine site, ranging from 8,512 cpm to 311,706 cpm. The measurements collected at the waste piles were found at maximum levels ranging from approximately 60,000 cpm to 300,000 cpm. The measurements are represented in Figures 1, 2, 5, and 6.

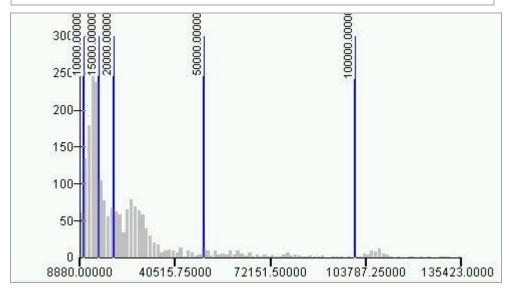
A total of 2,051 gamma radiation measurements were collected from the mine site, ranging from 8,880 cpm to 135,423 cpm. The measurements collected at the waste piles were found at maximum levels ranging from approximately 70,000 cpm to 130,000 cpm. The measurements are represented in Figures 1, 2, 5, and 6.

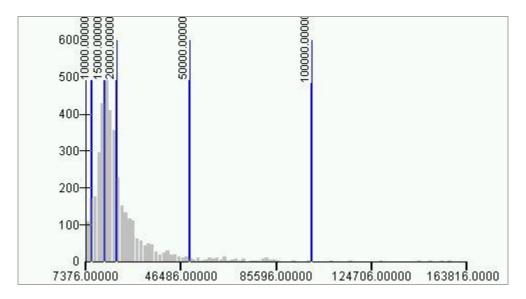
A total of 3,822 gamma radiation measurements were collected from the mine site, ranging from 7,376 cpm to 163,816 cpm. The measurements collected at the waste pile were found at a maximum level of approximately 160,000 cpm, and at the reclamation area at average levels ranging from approximately 15,000 cpm to 20,000 cpm. The measurements are represented in Figures 1, 2, 7, and 8.

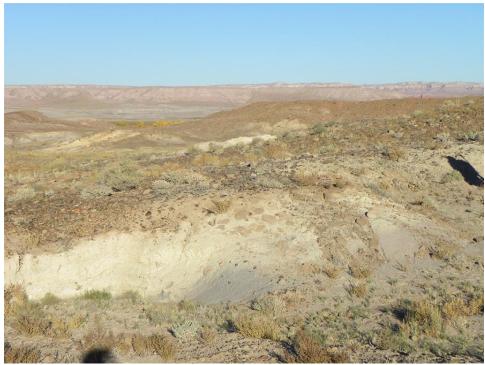
Photo 7. Charles Huskon No. 3, Site #138, waste piles and exposed material

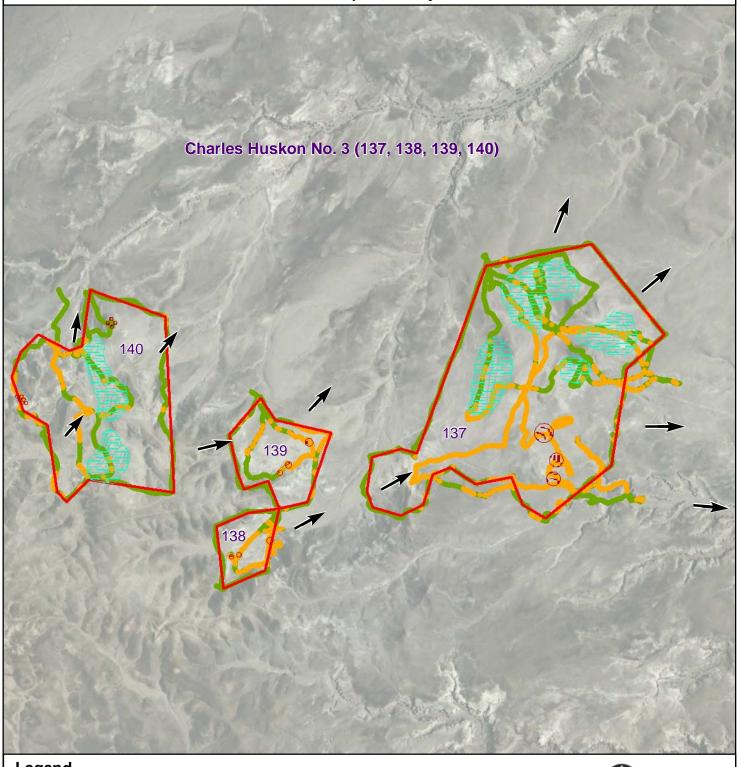
Figure 1 - Gamma Radiation Measurements, Above Two Times Background Charles Huskon No. 3 (137, 138, 139, 140) Cameron Chapter, Navajo Nation

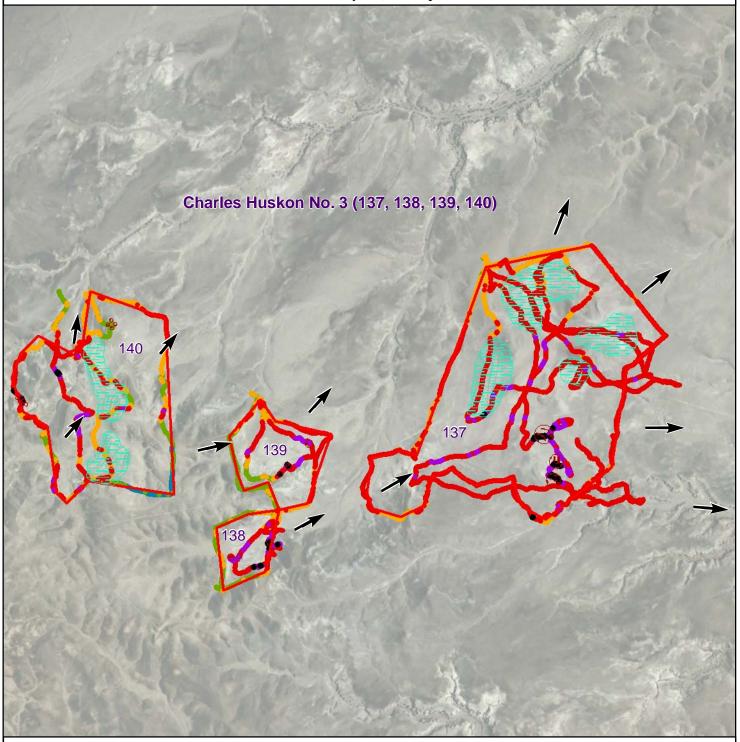
Figure 2 - Gamma Radiation Measurements Charles Huskon No. 3 (137, 138, 139, 140) Cameron Chapter, Navajo Nation

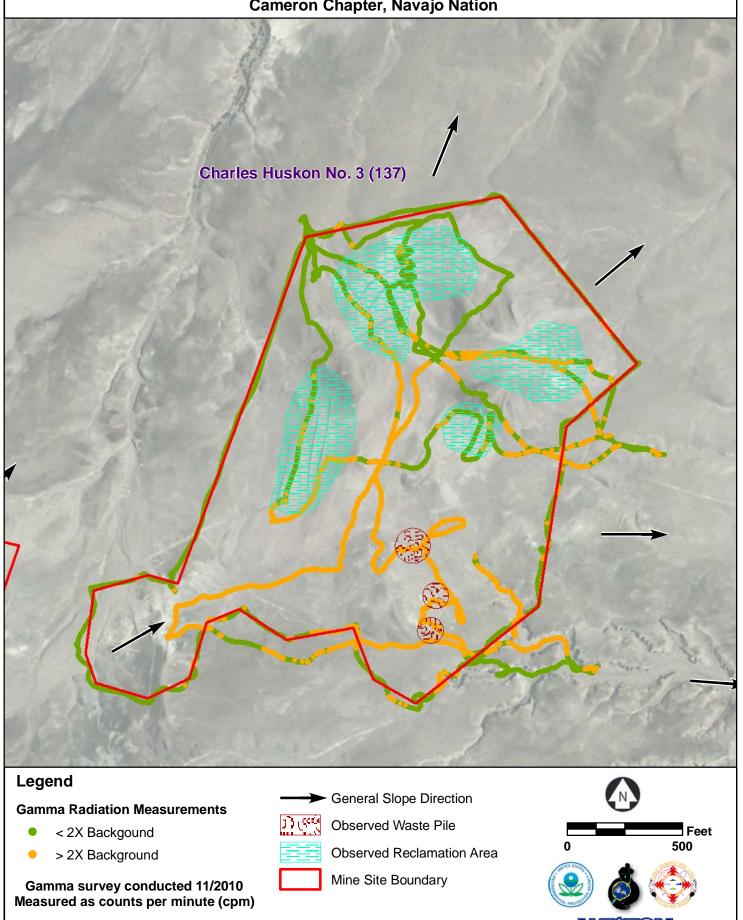
Figure 3 - Gamma Radiation Measurements, Above Two Times Background
Charles Huskon No. 3 (137)
Cameron Chapter, Navajo Nation

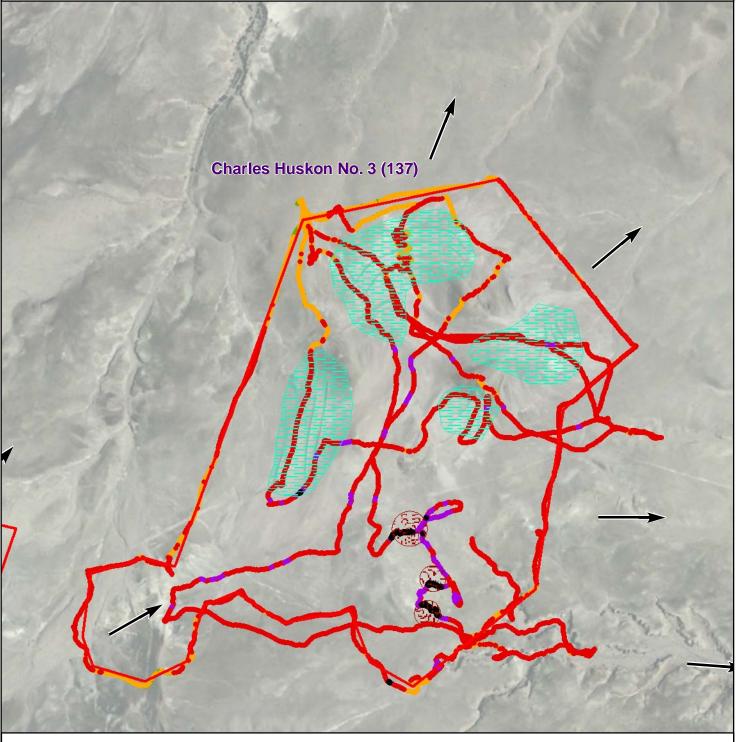
Figure 4 - Gamma Radiation Measurements Charles Huskon No. 3 (137) Cameron Chapter, Navajo Nation

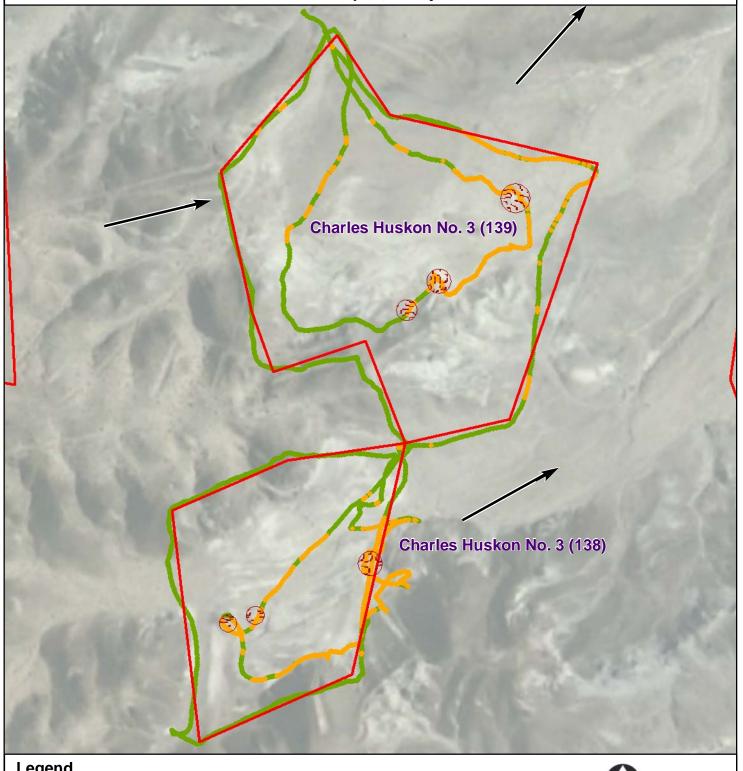
Figure 5 - Gamma Radiation Measurements, Above Two Times Background **Charles Huskon No. 3 (138, 139) Cameron Chapter, Navajo Nation**

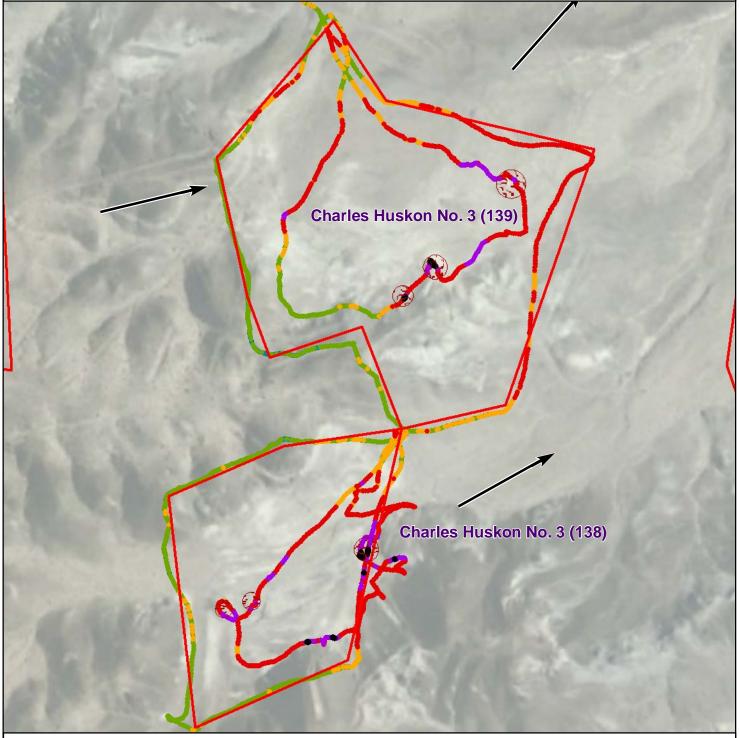
Figure 6 - Gamma Radiation Measurements Charles Huskon No. 3 (138, 139) Cameron Chapter, Navajo Nation

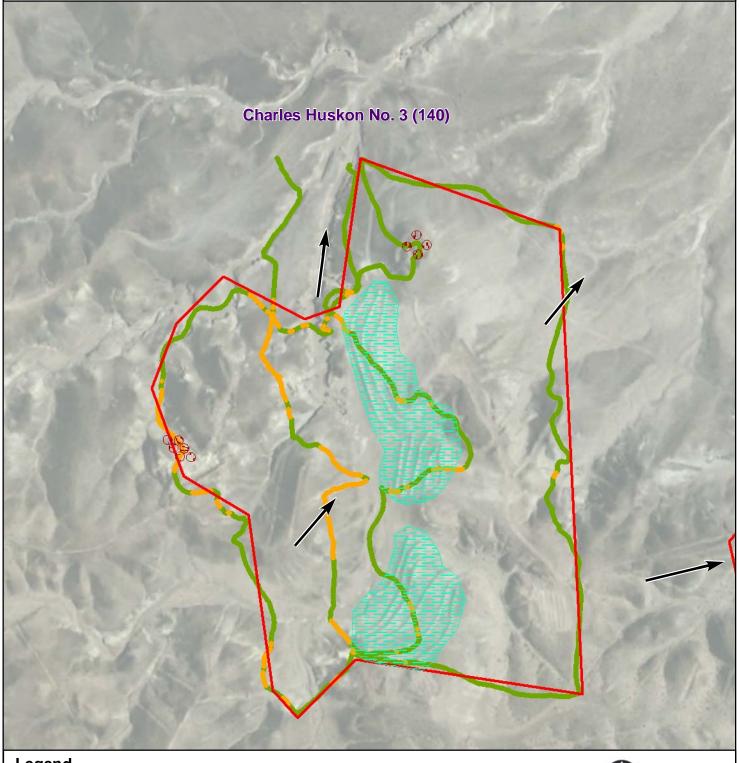
Figure 7 - Gamma Radiation Measurements, Above Two Times Background
Charles Huskon No. 3 (140)
Cameron Chapter, Navajo Nation

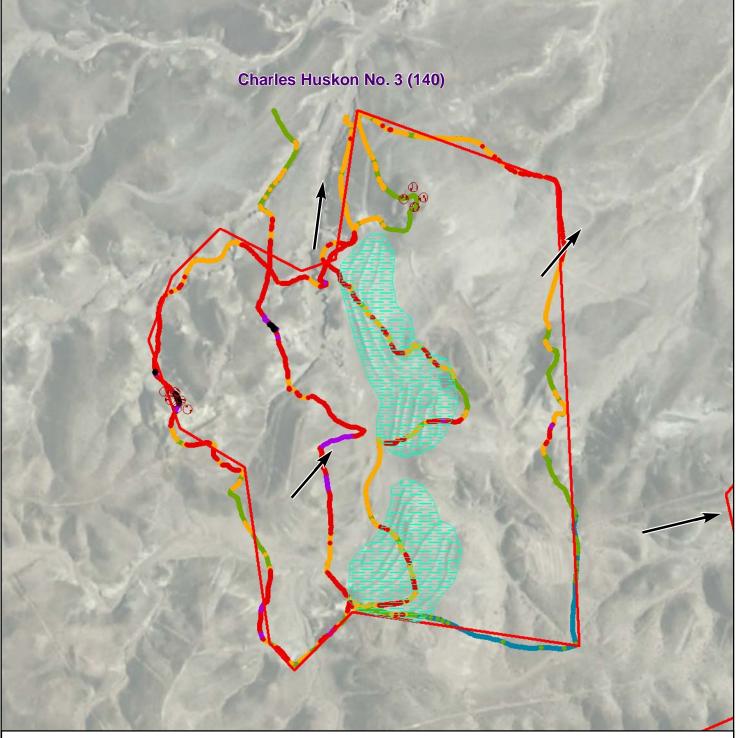
Figure 8 - Gamma Radiation Measurements Charles Huskon No. 3 (140) Cameron Chapter, Navajo Nation
